DRAFT AFTER ACTION REPORT

**Hi-Tech Plating Facility
Balch Springs, Dallas County, Texas**

**EPA - REGION VI
EMERGENCY RESPONSE BRANCH**

**Ecology and Environment, Inc.
Technical Assistance Team**

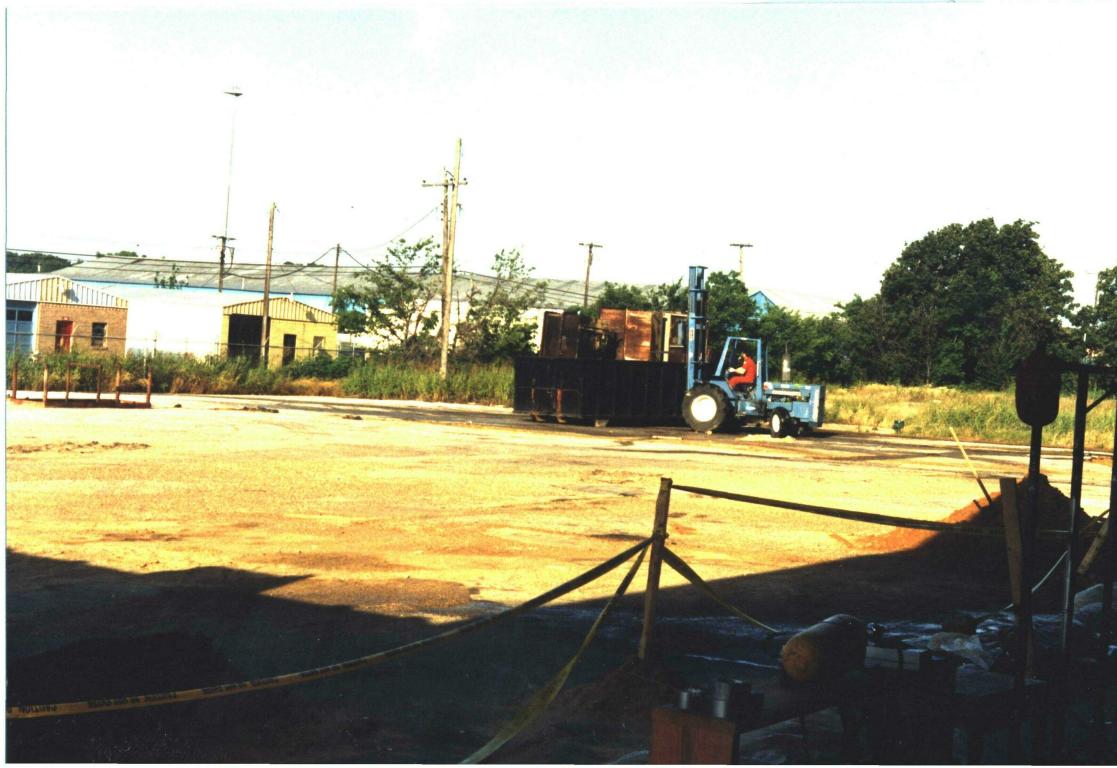
Comments: Crew movin cleaned vats with forklift for scrap metal disposal.

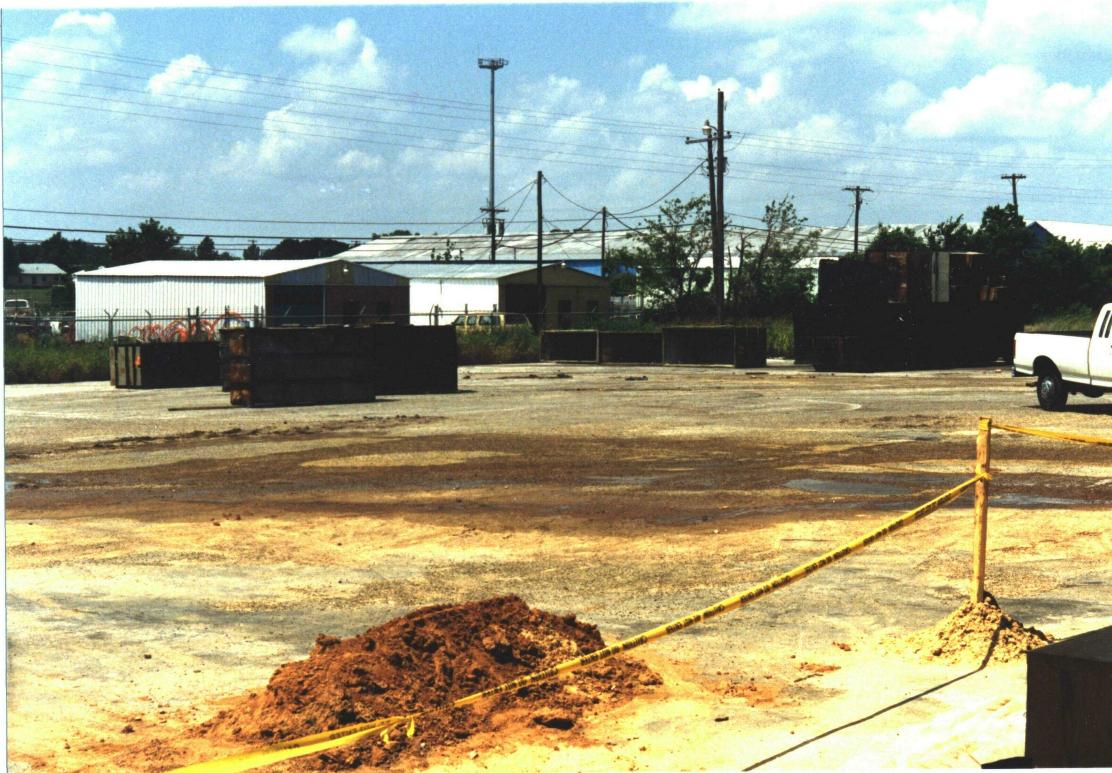
Comments: Cleaned vats in parking lot
awaiting disposal by scrap metal vendor.

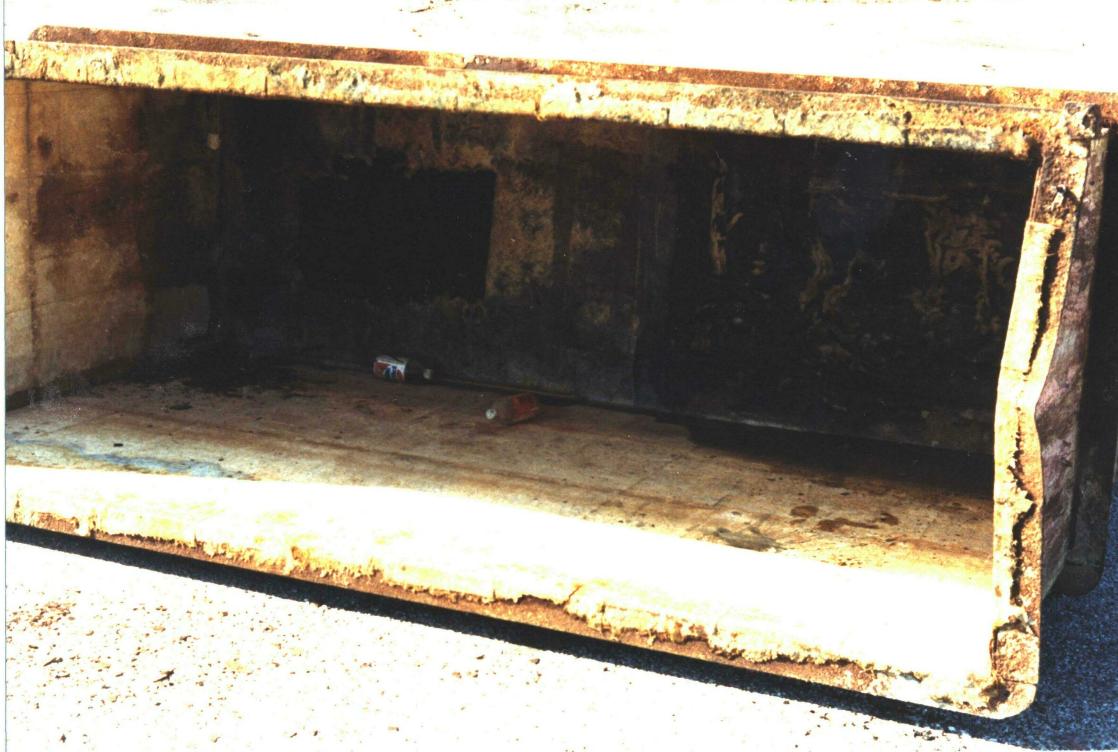
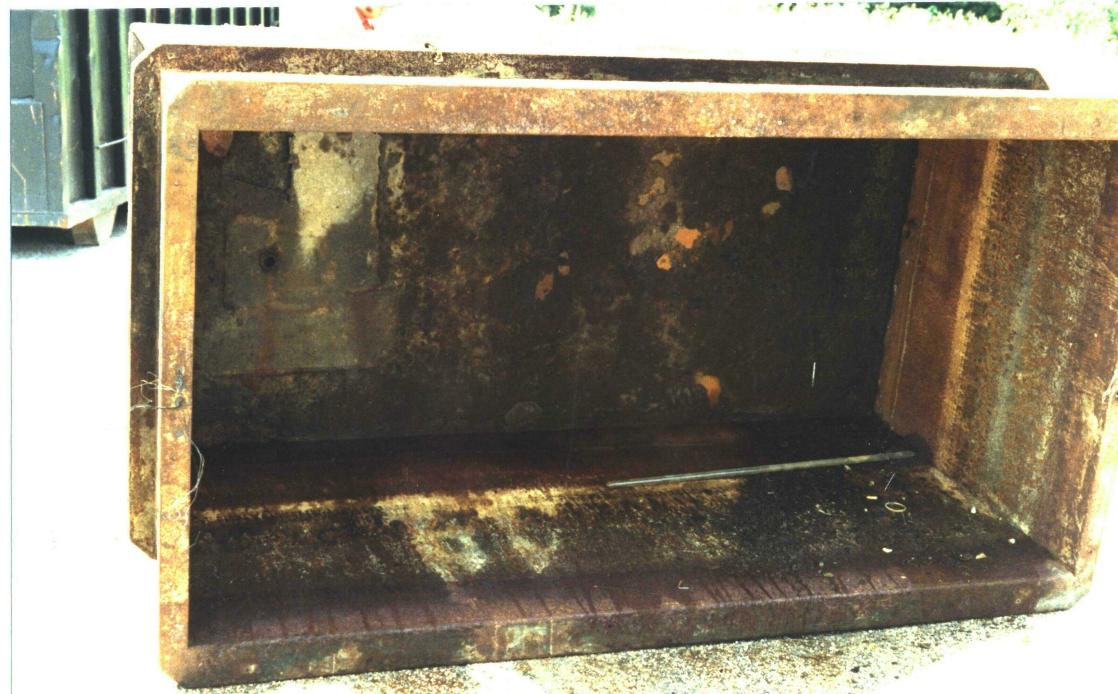
6-11-90/ 1200/ S

Comments: Vats cleaned and awaiting
pickup by scrap metal vendor.

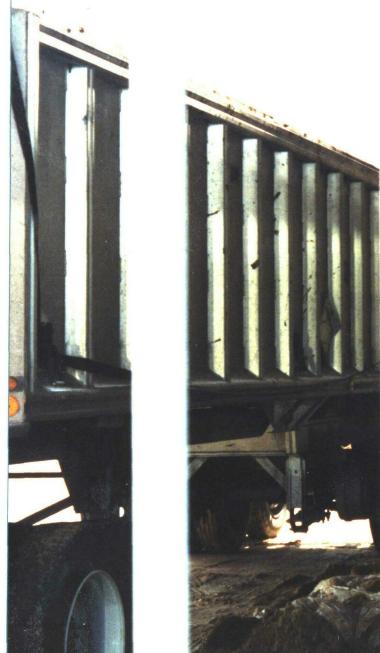
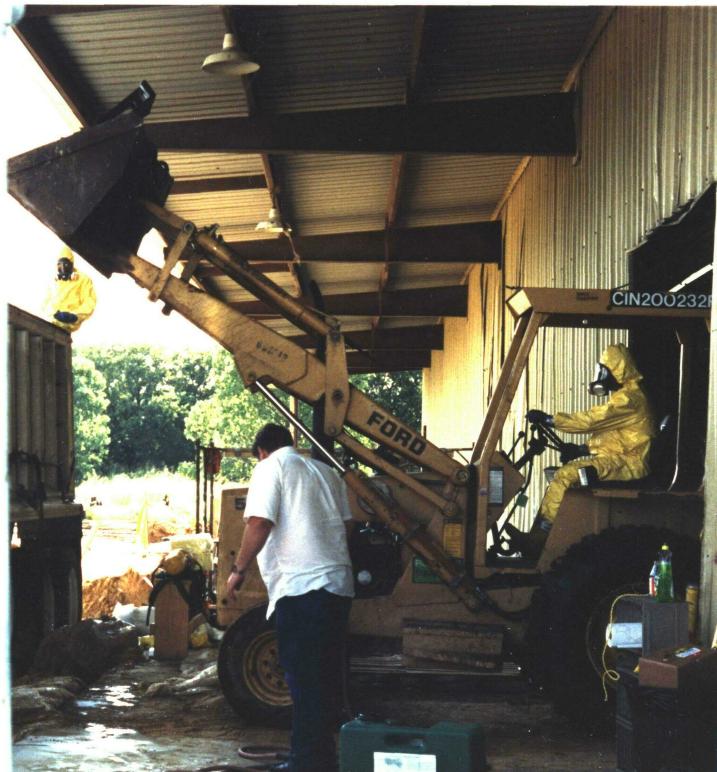
6-12-90/1310/ SW

Comments: Crew piling debris on floor for offsite disposal in truck.

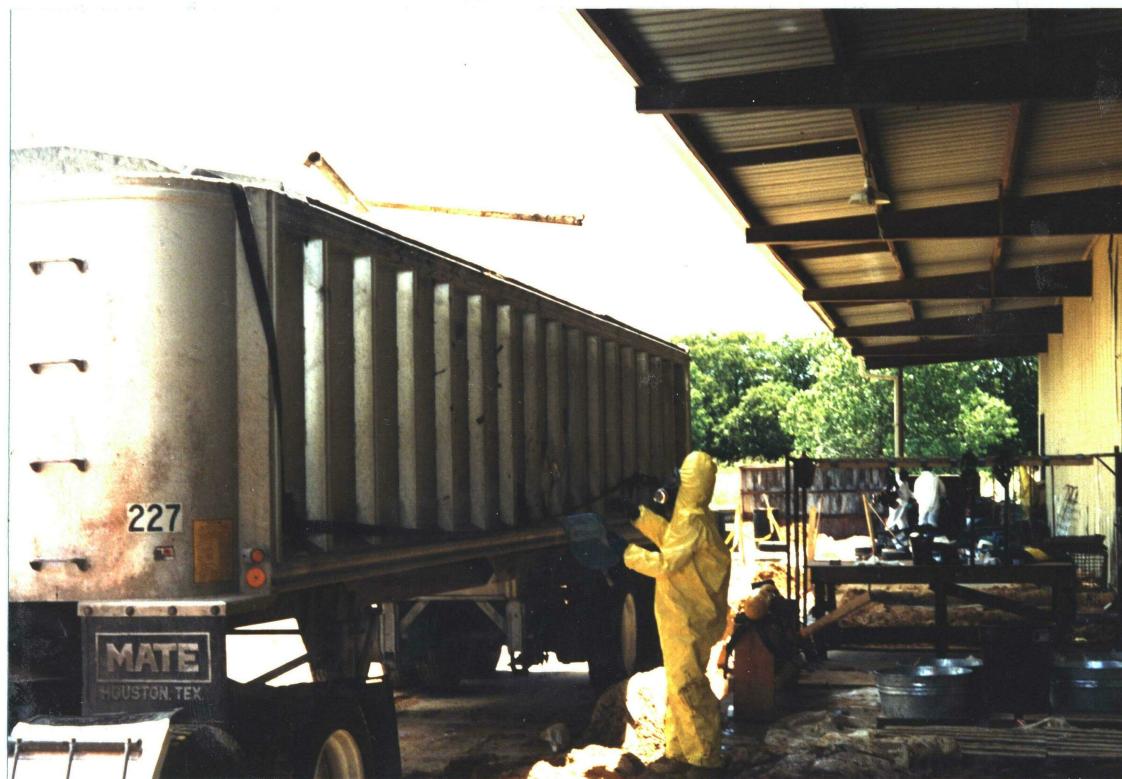
6-12-90/ 1410/ W

Comments: Crew loading site debris into disposal truck.

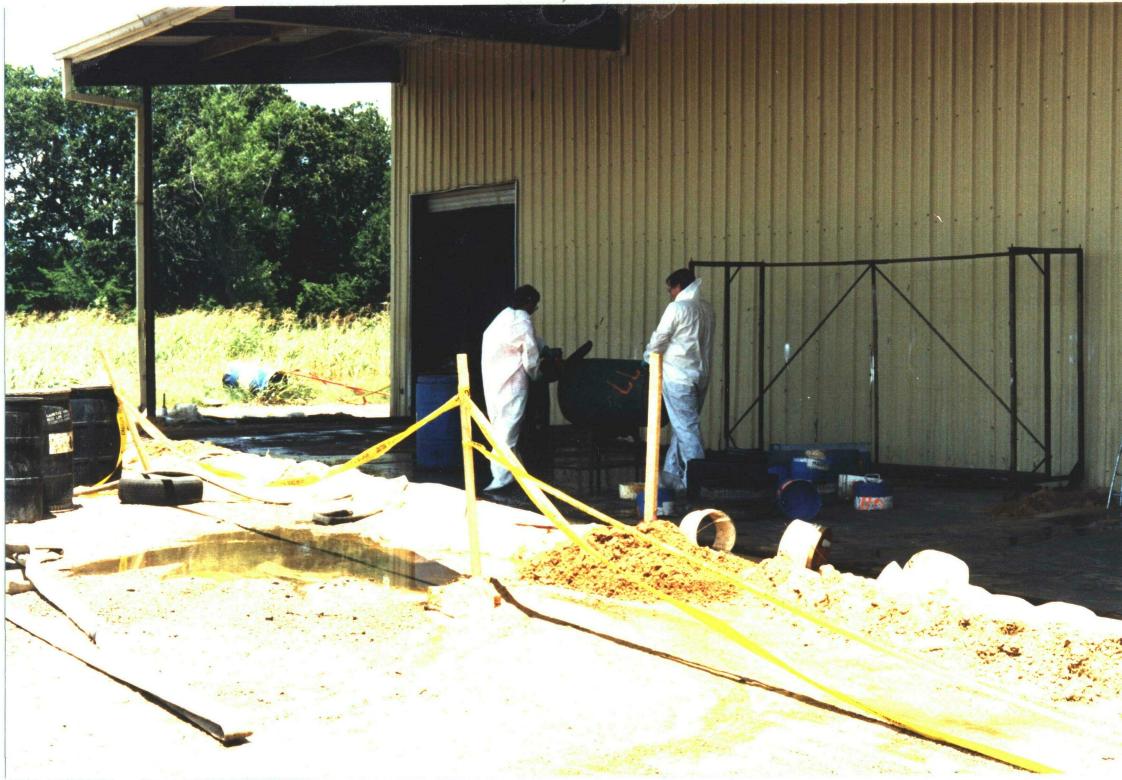
6-12-90/ 1510/W

Comments: Crew loading debris into disposal truck.

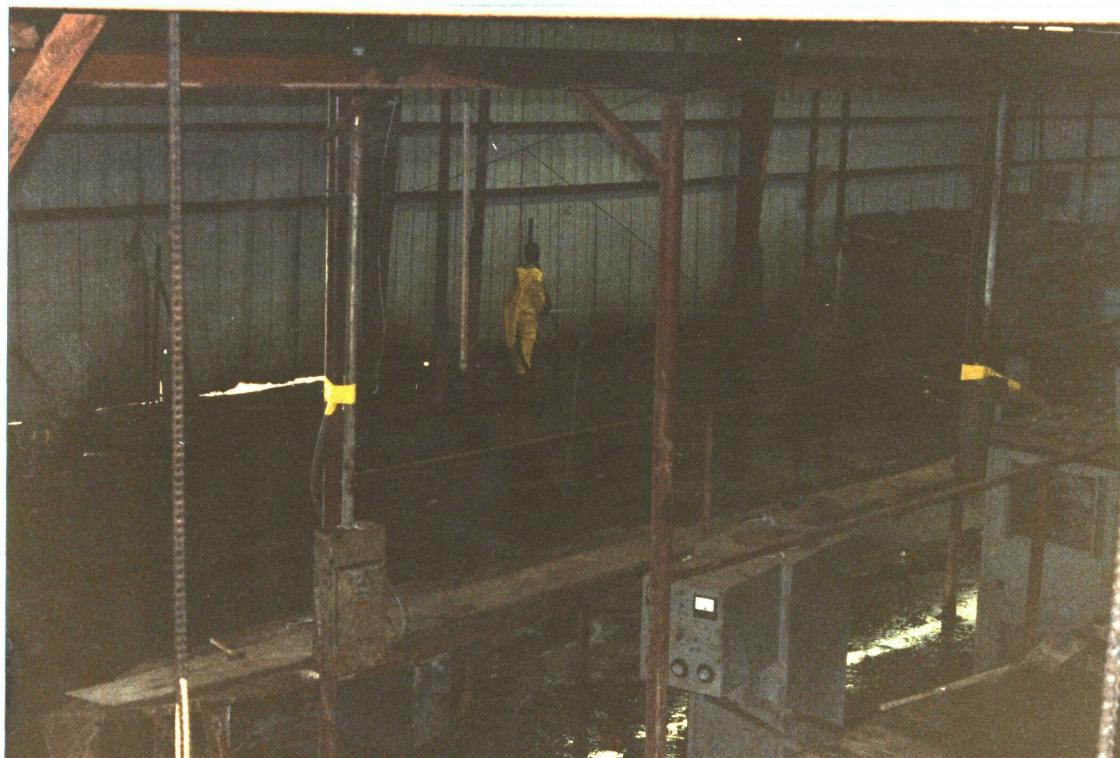
6-13-90/ 1730/ SW

Comments: Crew rinsing floor for final
time.

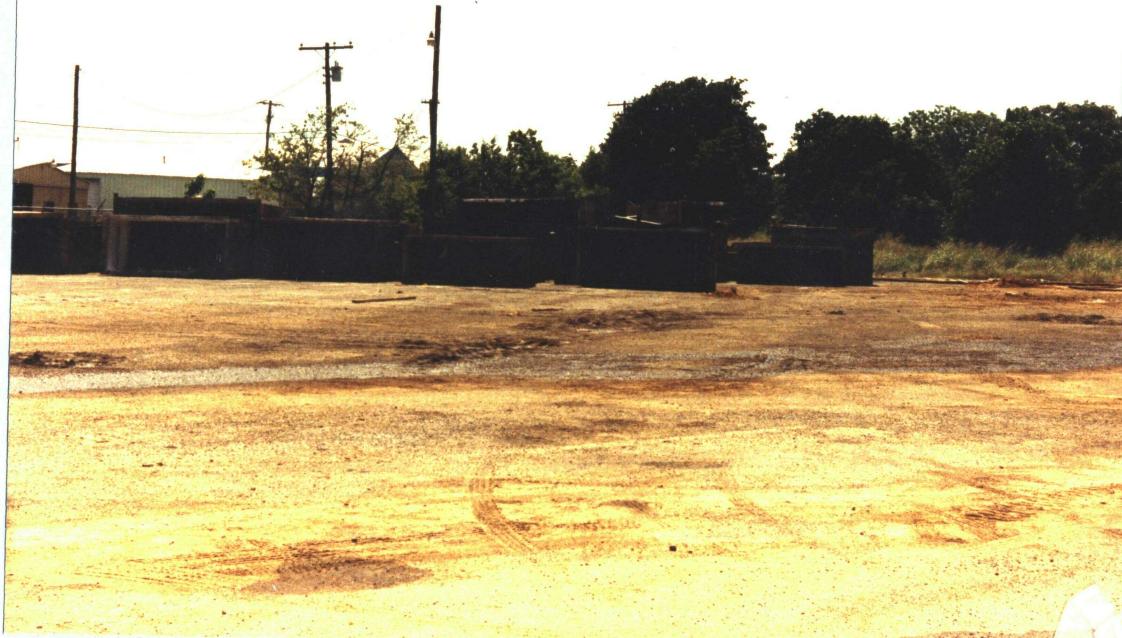
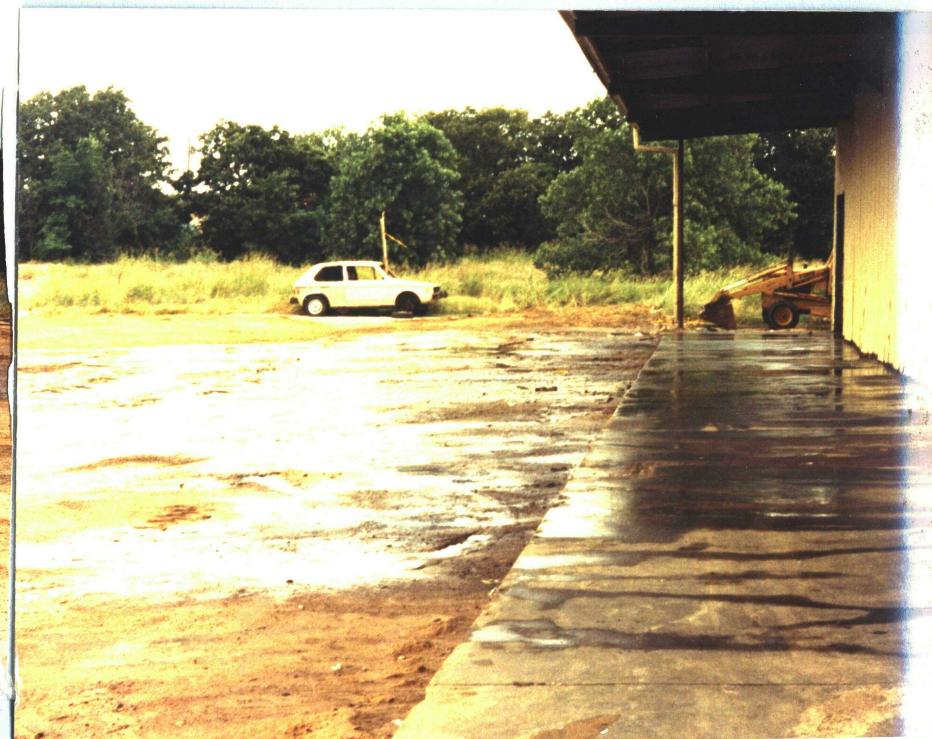
6-14-90/ 1800/ S

Comments: Parking lot area after the
completion of the removal action.
